Pre-sale Technical Support

1 Pre-sale maintenance:

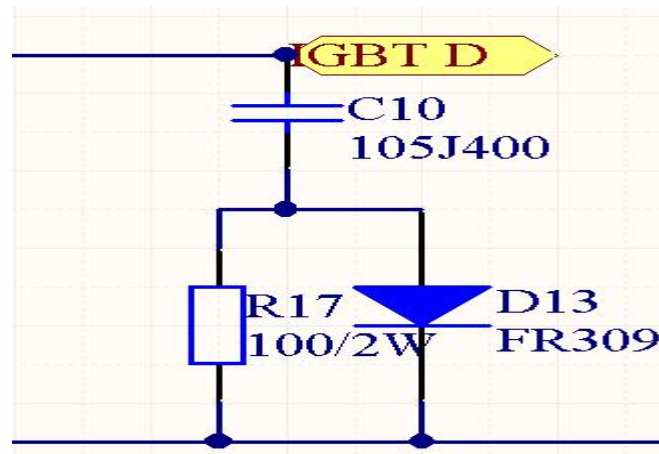
Phenomenon: IGBT explodes and bursts during high-power test

Cause 1: The diode D13 of the RCD snubber circuit is reversed, the capacitance is not correct, or the resistance of the resistor is too large. The RCD snubber circuit is shown below:

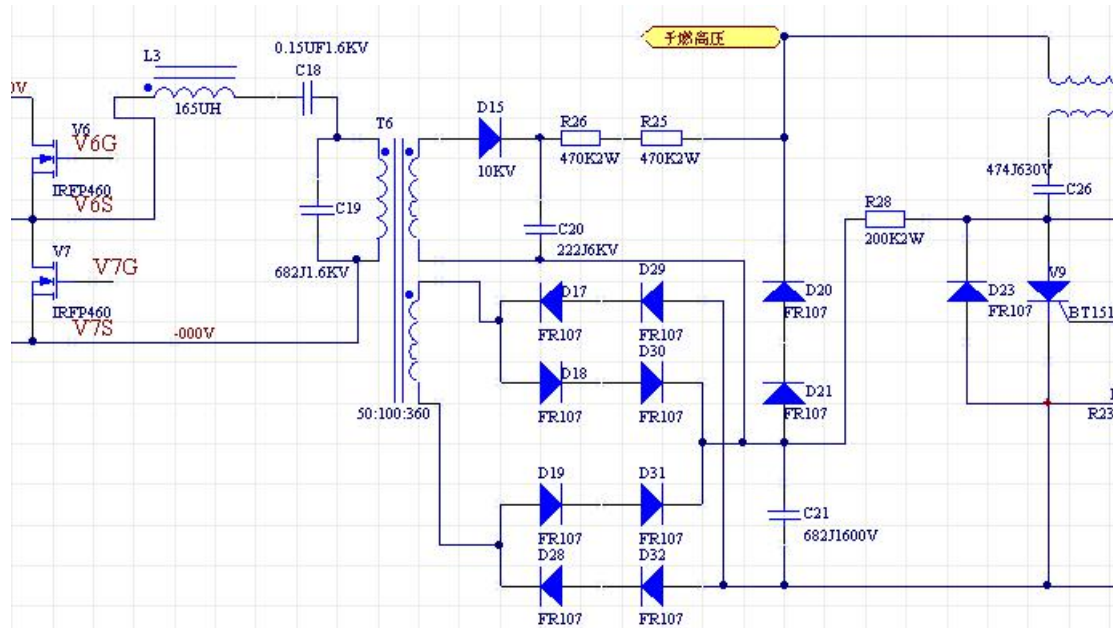
Phenomenon: Strong test, pre-ignition unsuccessful, lighting test error (failure) (technique)

Cause: The EI33 (L3), EI40 (T6), and 8 FR107 (rectified parts) and feedback optocoupler PC817 (IC2) are damaged. As shown in the figure below, pay special attention to checking D23 (FR107) for damage.

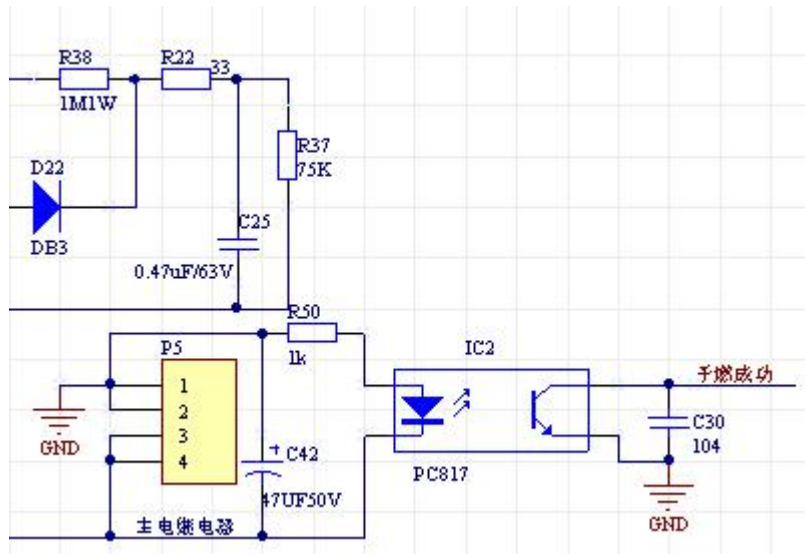
The following figure shows a successful pre-ignition feedback circuit. Sometimes it can be pre-ignited, but it cannot be fed back correctly. The PC817 must be replaced.

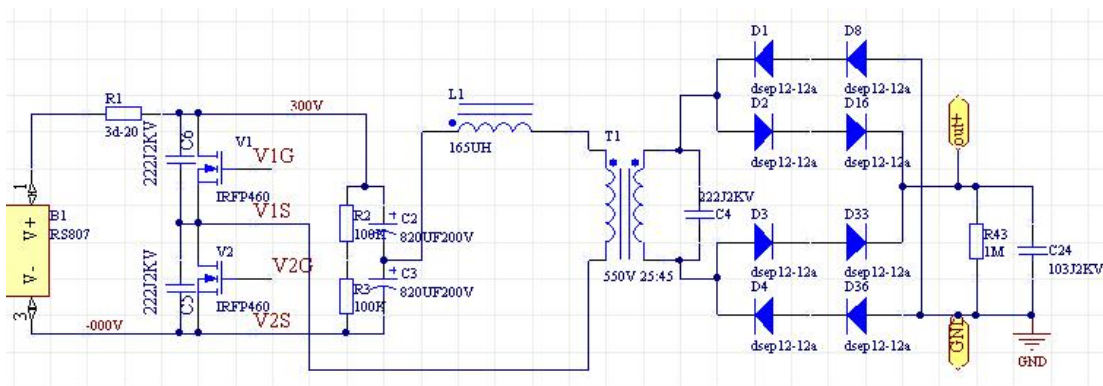
Phenomenon: Strong test, can't charge, there is a problem with charging circuit (technique)

Cause: The EI40 inductor (L1) and PQ50 transformer (T1) are damaged, and the rectifier diode HER308 (8) is damaged. The following figure shows a charging-related schematic diagram. GDN and OUT+ are connected to the negative and positive electrodes of the charging capacitor, respectively.

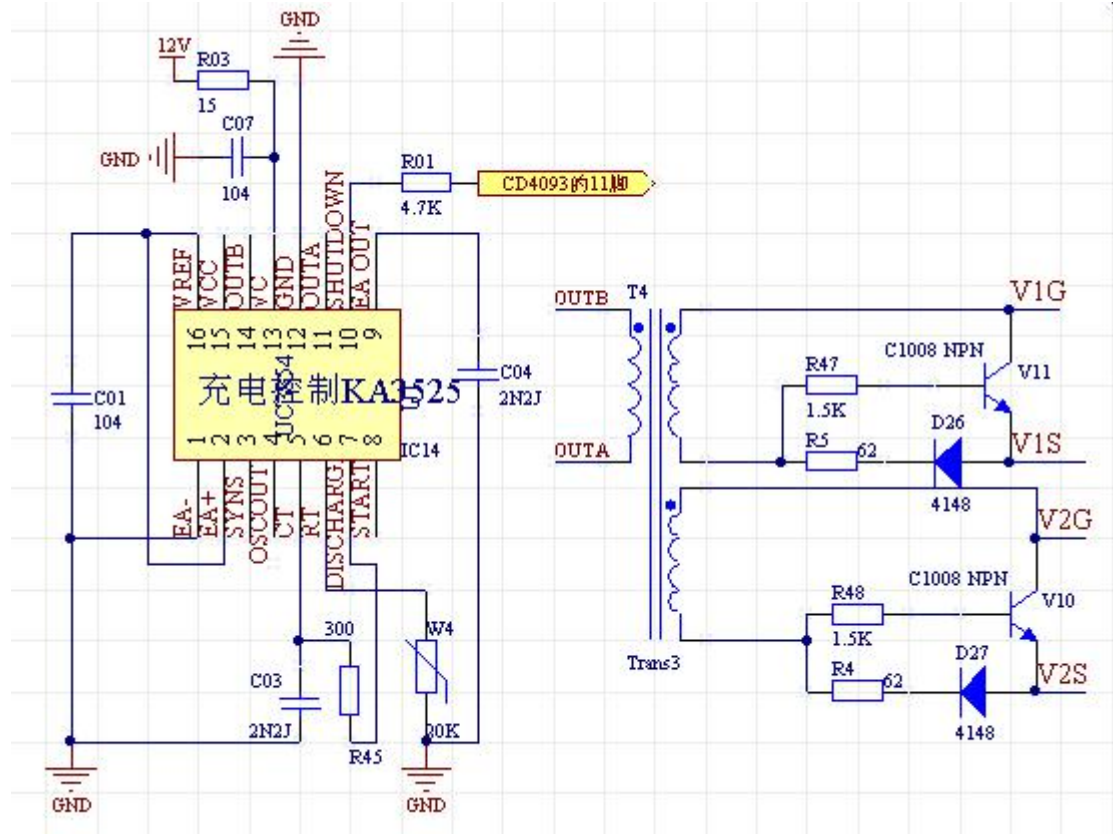
Charging part of the driving circuit 1

Phenomenon: Weak current test, charging part IRFP460 without driving waveform (technique)

Cause: The LM393 is damaged. The inspection method is as follows. On the weak current, measure the voltage of pin 12 (GND) of KA3525 and pin 11 of CD4093 with DC voltage range of multimeter. The normal value should be zero; if the measured value is about 11V, check the first pin of LM393 and The voltage of the 7th foot to the earth, the normal value is about 11V; if the measured value is about 3.93V, then change the LM393.
