Pre-sale Technical Support

1 Pre-sale maintenance:

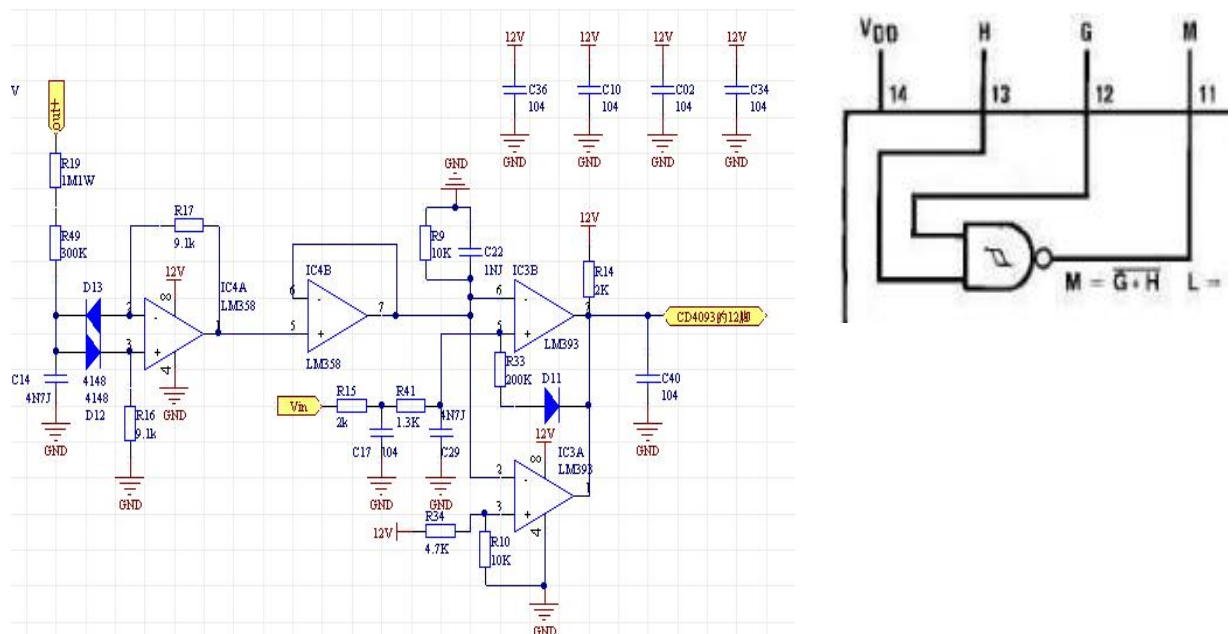
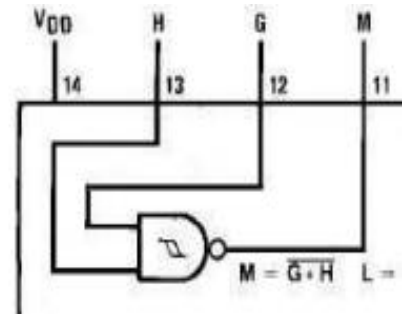
Charging part of the driving circuit 1

The CD4093 consists of four Schmitt trigger circuits with two inputs. Each circuit is a 2-input NAND gate with a Schmitt trigger function. As shown in the lower right figure, each gate is turned on and off at different points on the rising and falling edges of the signal. The difference between the rising voltage (V_{PT}) and the falling voltage (V_N) is defined as the hysteresis voltage (ΔV_T).
